# Marmora and Lake Facilities Review – 2020

Prepared for:  
The Municipality of Marmora and Lake  
12 Bursthall Street  
Marmora, ON  
K0K 2M0

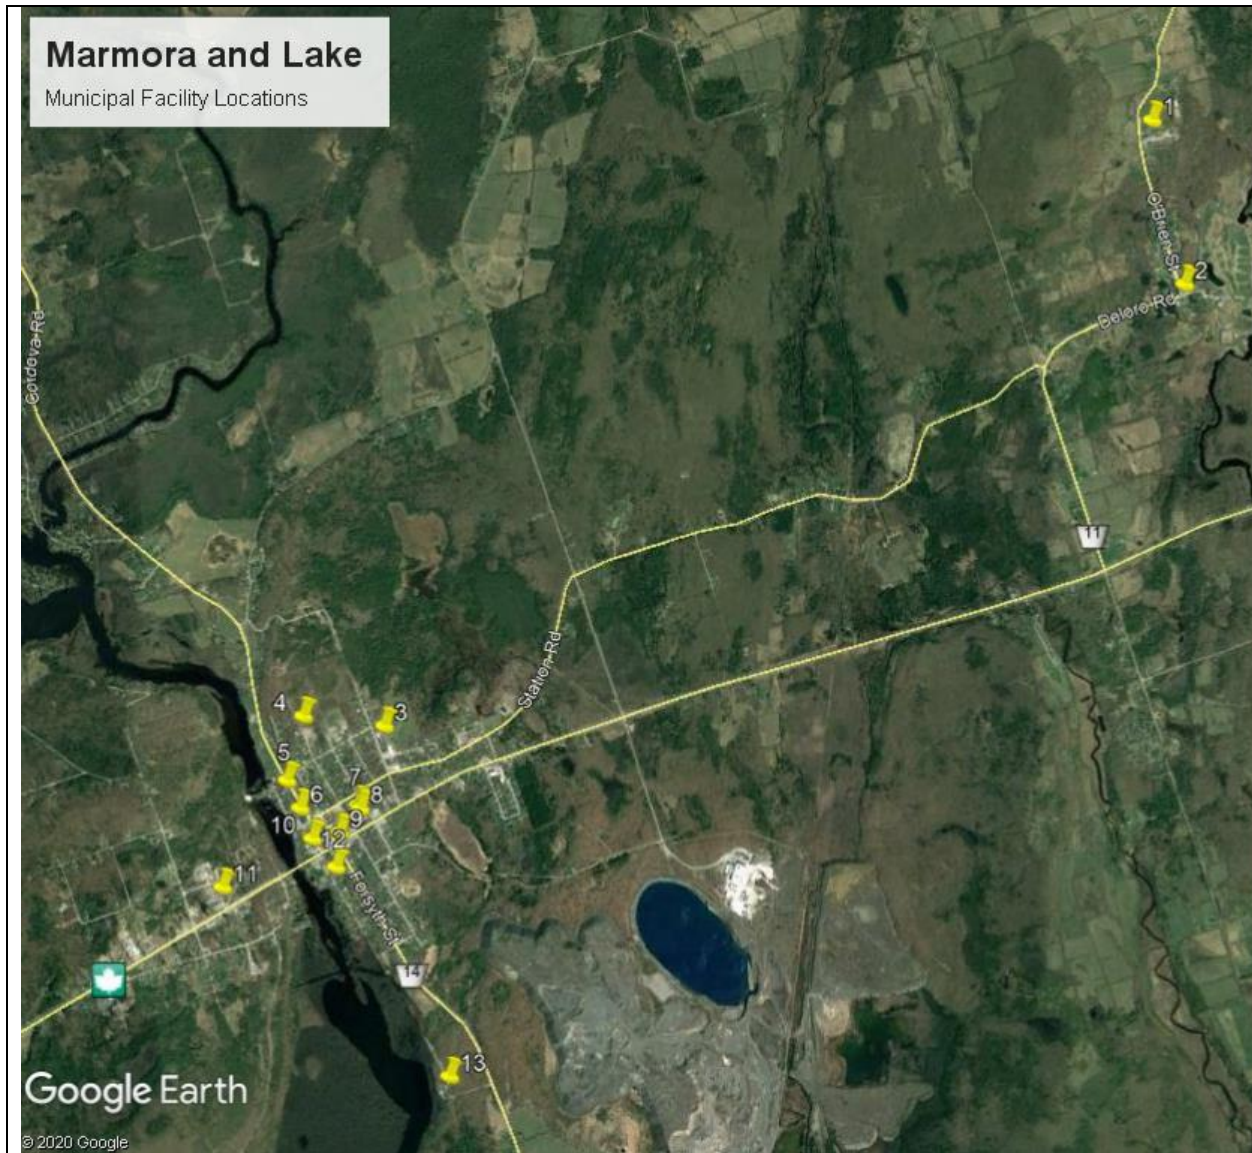
- 1. Marmora Public Works Garage
- 2. Deloro Community Centre
- 3. Community Centre/Curling Club
- 4. Water Tower Building
- 5. Water Treatment Plant
- 6. Medical Centre
- 7. Municipal Office

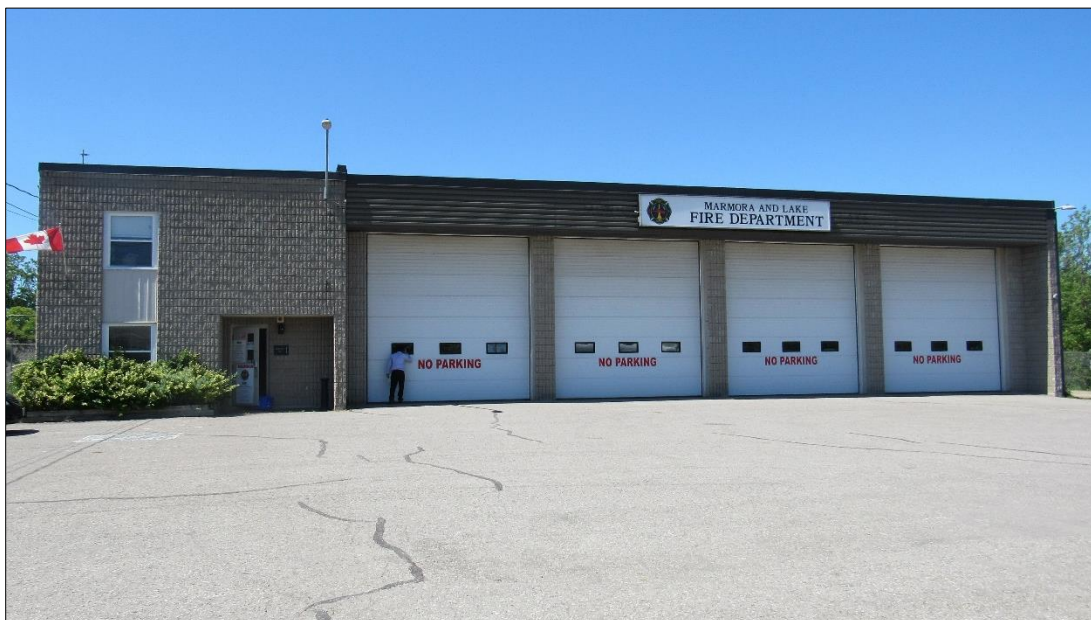
**Figure 1 - Marmora Fire Hall**

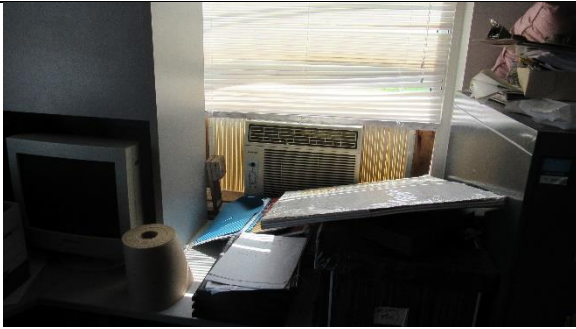
Figure 2 - Window air conditioner

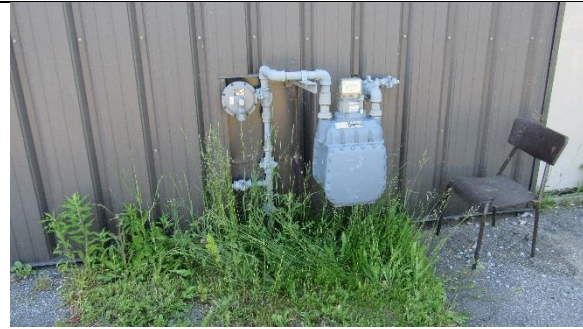
Figure 3 - Unprotected gas service

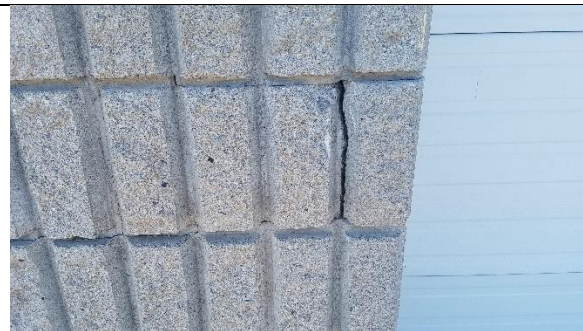
Figure 6 - Cracks in the joints of brick veneer

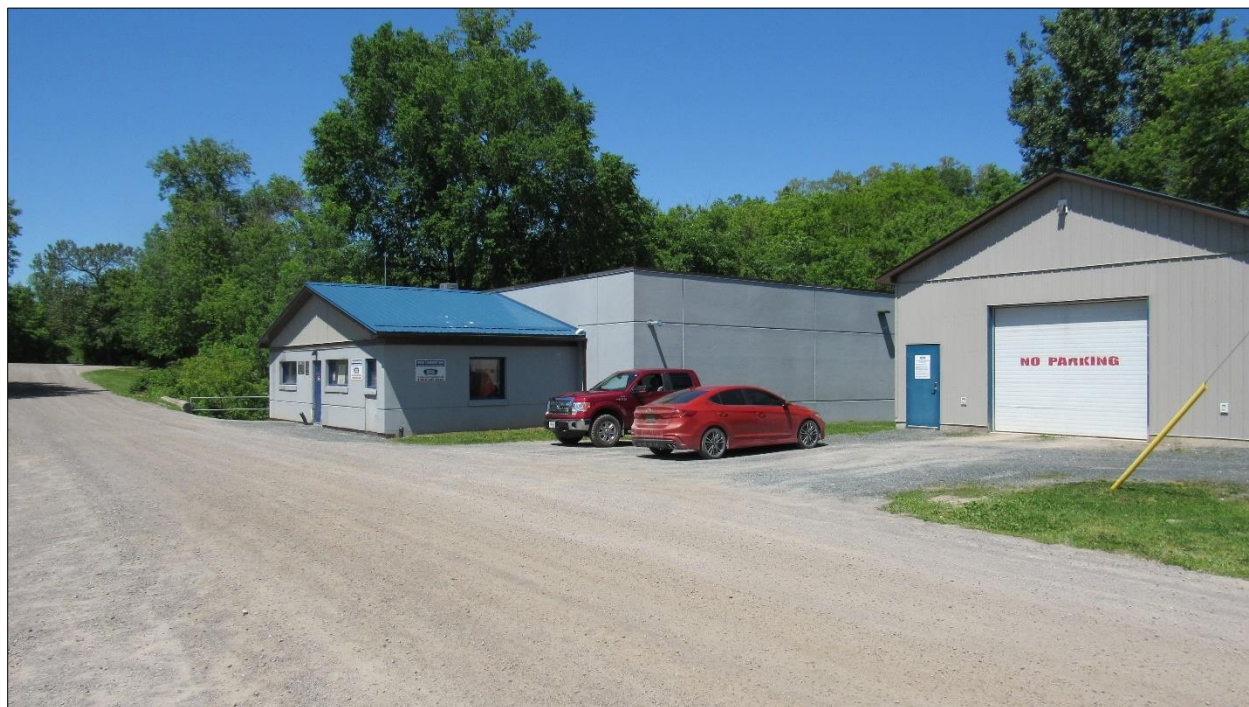
**Figure 7 - Marmora Water Treatment Plant**

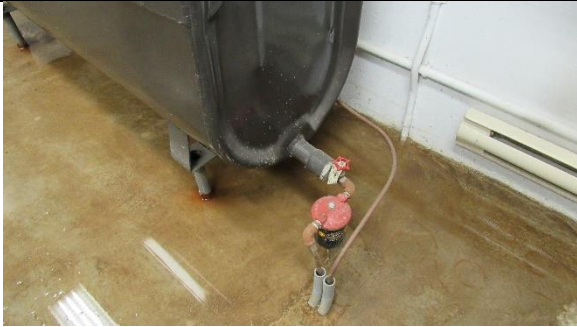
**Figure 8 - Oil tank with bottom draw. Water ponding also noted.**

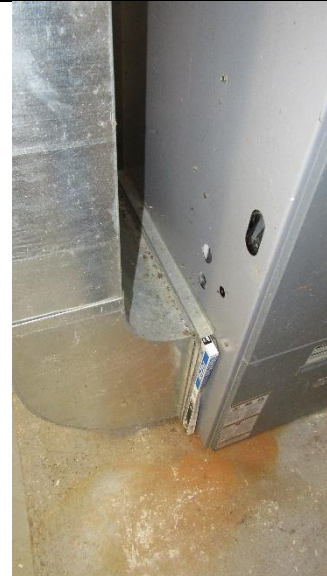
**Figure 9 - Improperly sized furnace filter**

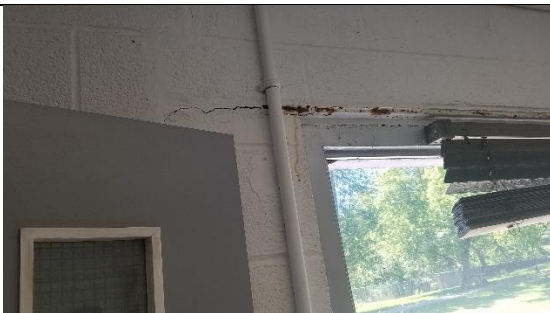
**Figure 10 - Cracked and corroded lintel**

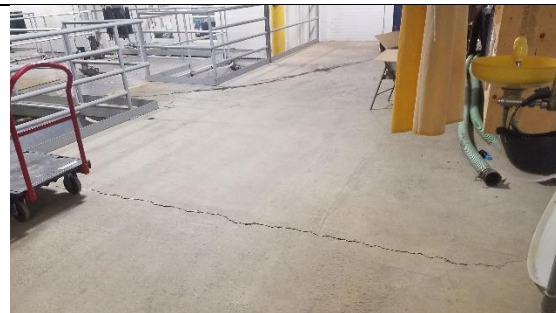
**Figure 11 - Crack in the concrete floor**

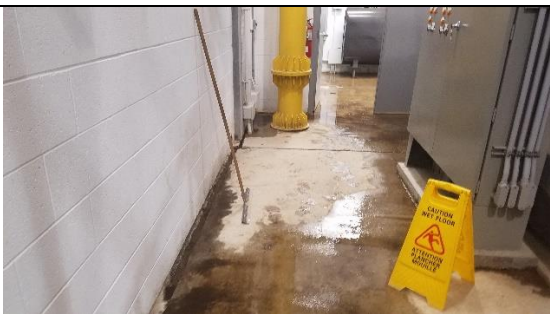
**Figure 12 - Poorly drained floor**

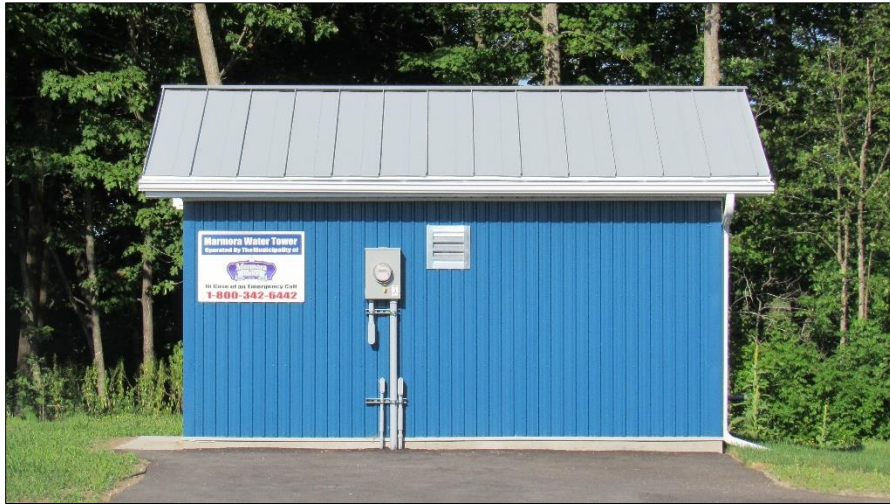
**Figure 13 - Marmora Water Tower Equipment Building**

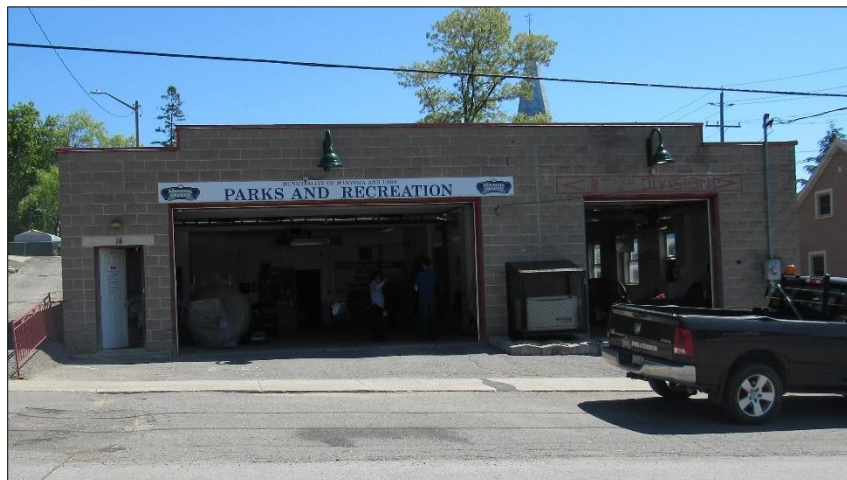
**Figure 14 - Marmora Parks and Recreation Garage**

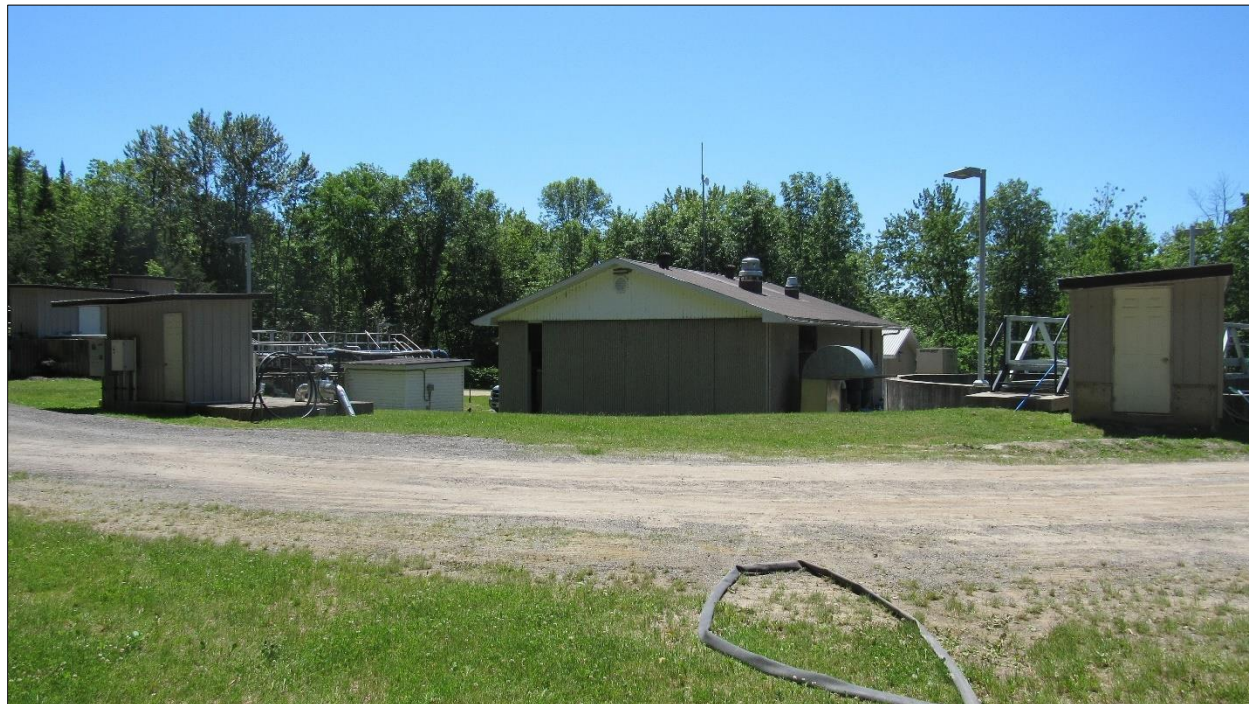
**Figure 16 - Marmora Waste Water Treatment Plant**

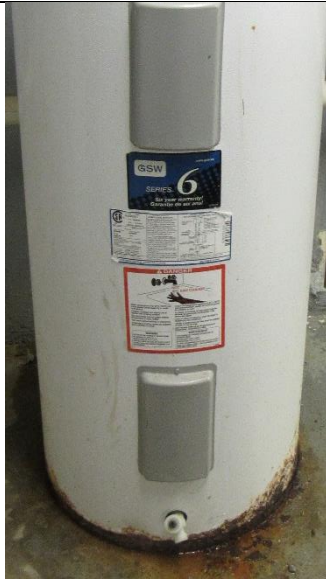
Figure 17 - Corrosion of HWT

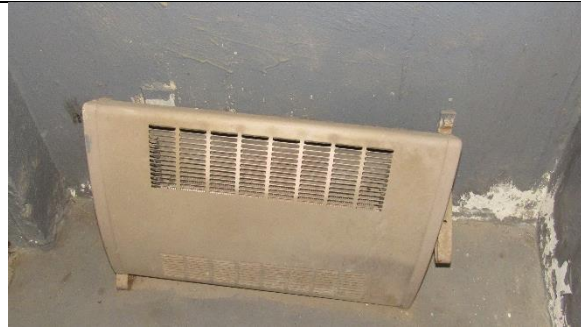
Figure 18 - Disconnected heater

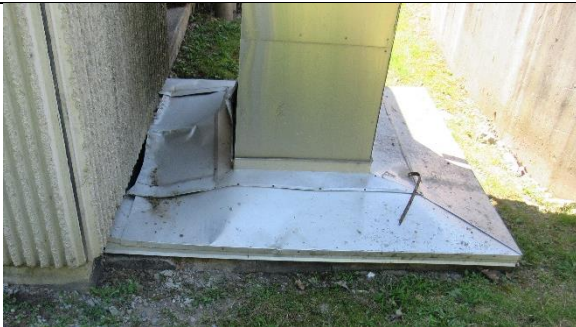
Figure 19 - Damaged external ducting

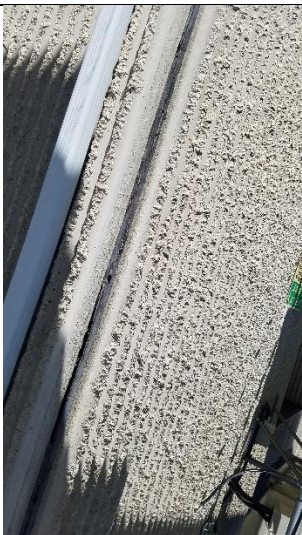
Figure 20 - Seal the joint of concrete panel deteriorated (main)

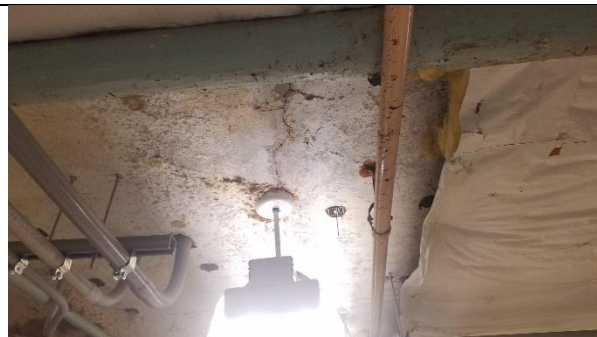
Figure 21 - Concrete cracks in the ceiling (main)

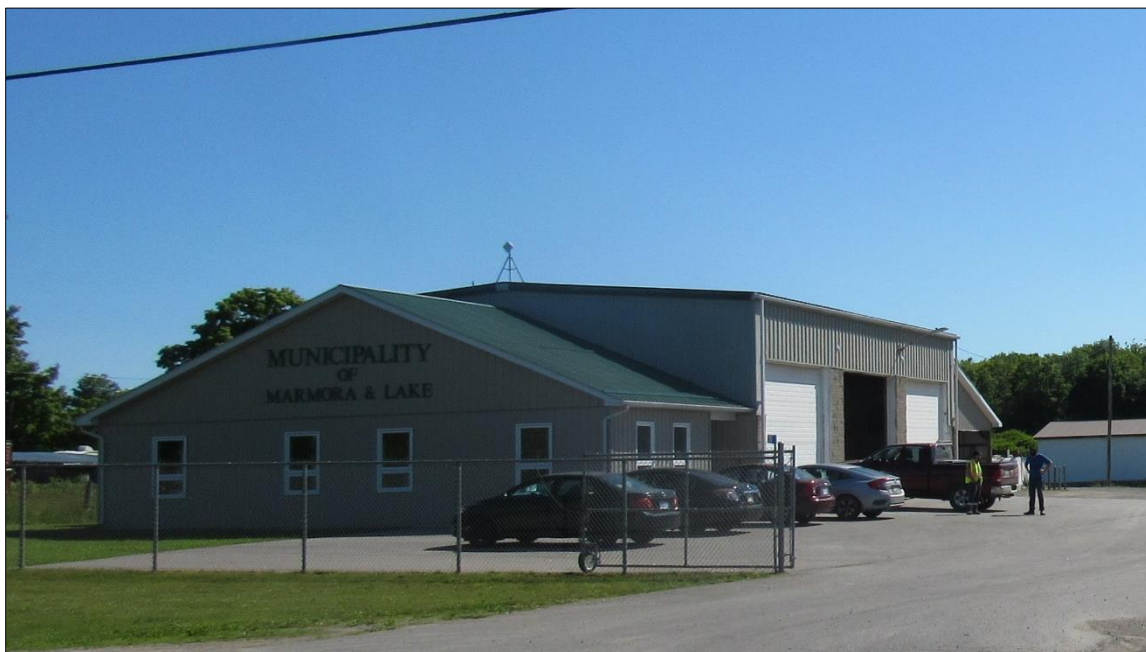
**Figure 22 - Marmora Public Works Garage**

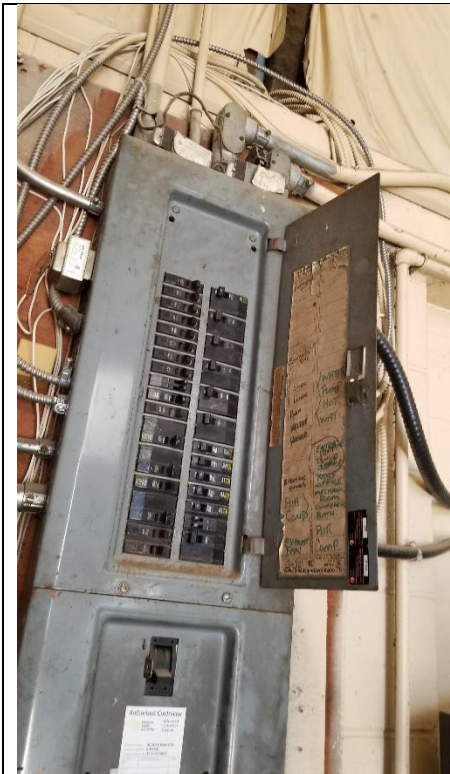
Figure 23 - Electrical panel for replacement

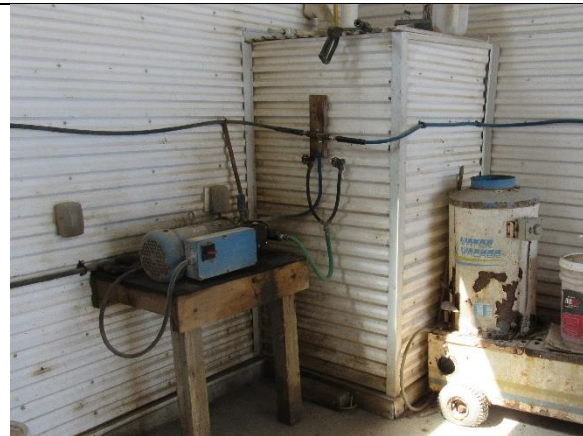
Figure 24 - Concealed HWT in wash bay

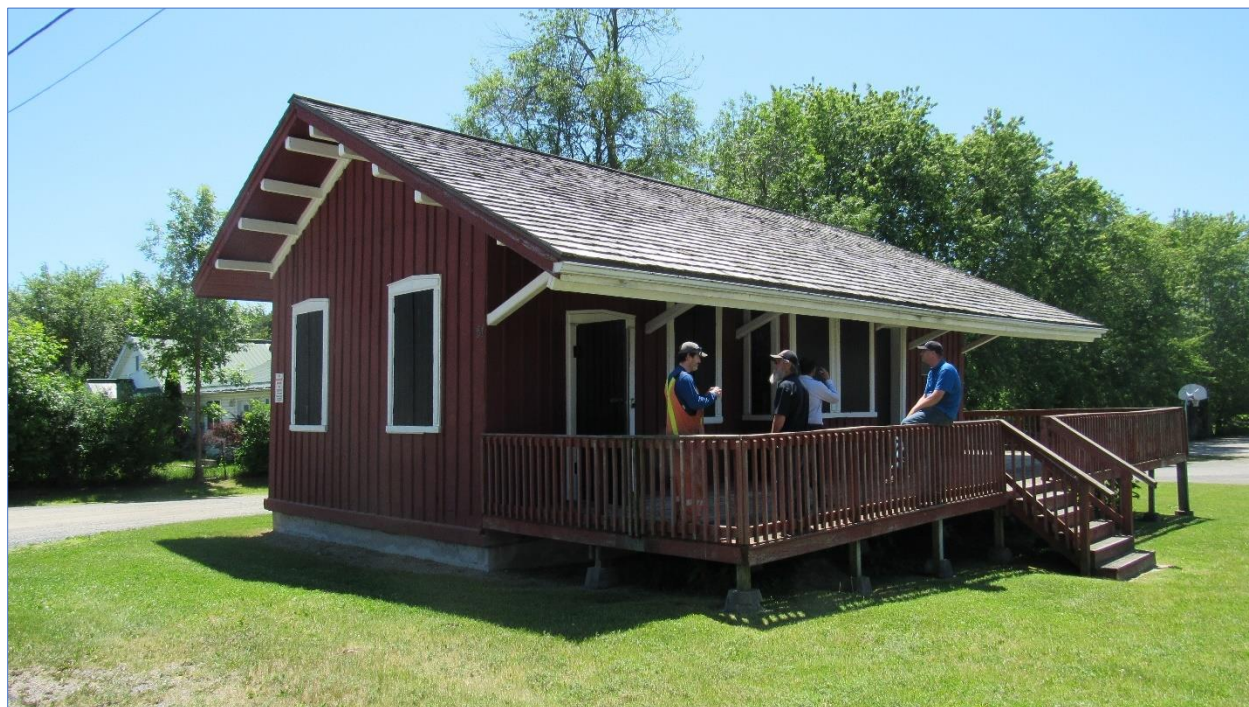
**Figure 25 - Marmora Train Station**

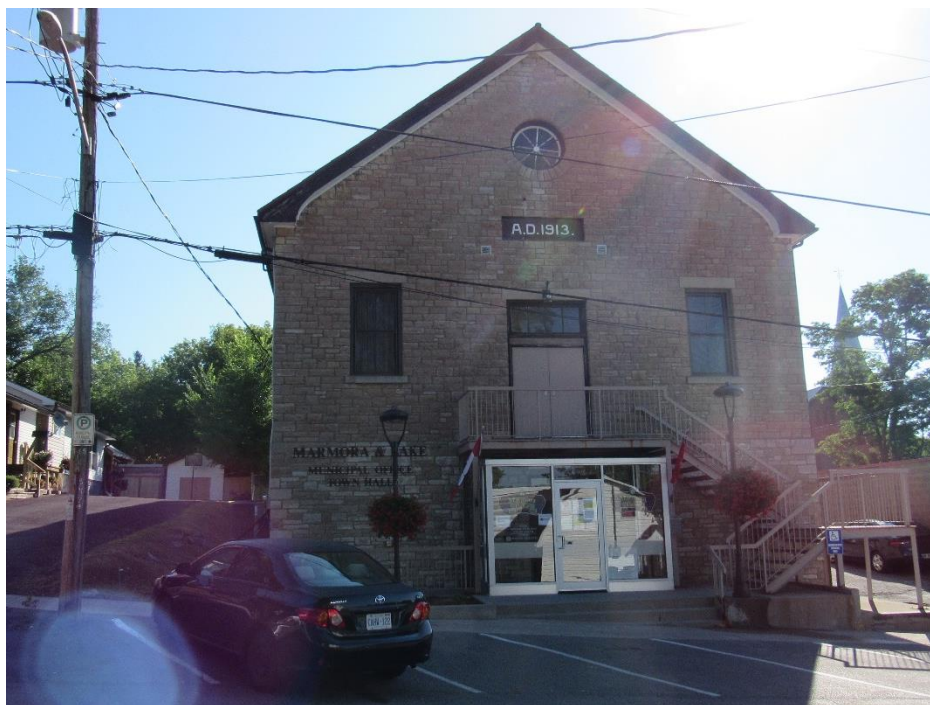
**Figure 26 - Marmora and Lake Municipal Offices**

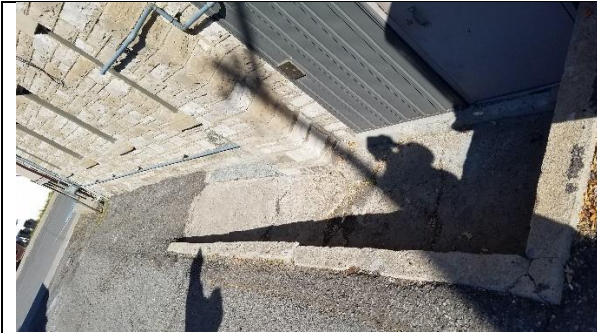
Figure 27 - Side entrance

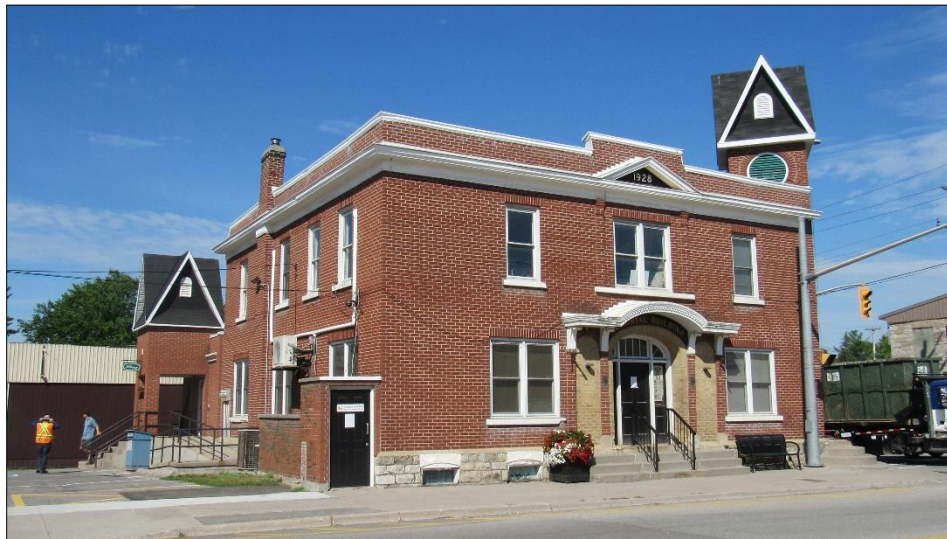
**Figure 30 - Marmora and Lake Library**

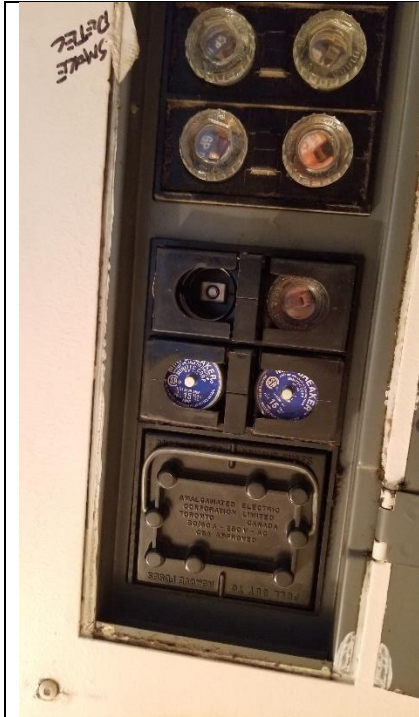
Figure 31 - Fuse panel for replacement

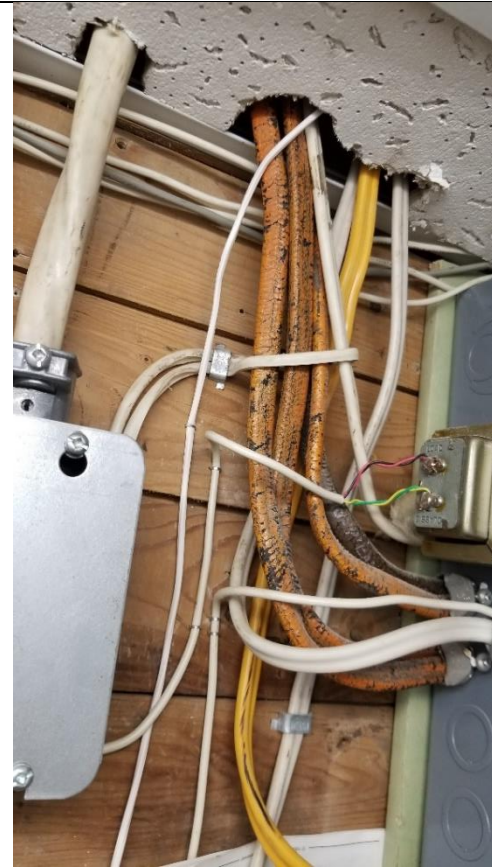
Figure 32 - Outdated wiring

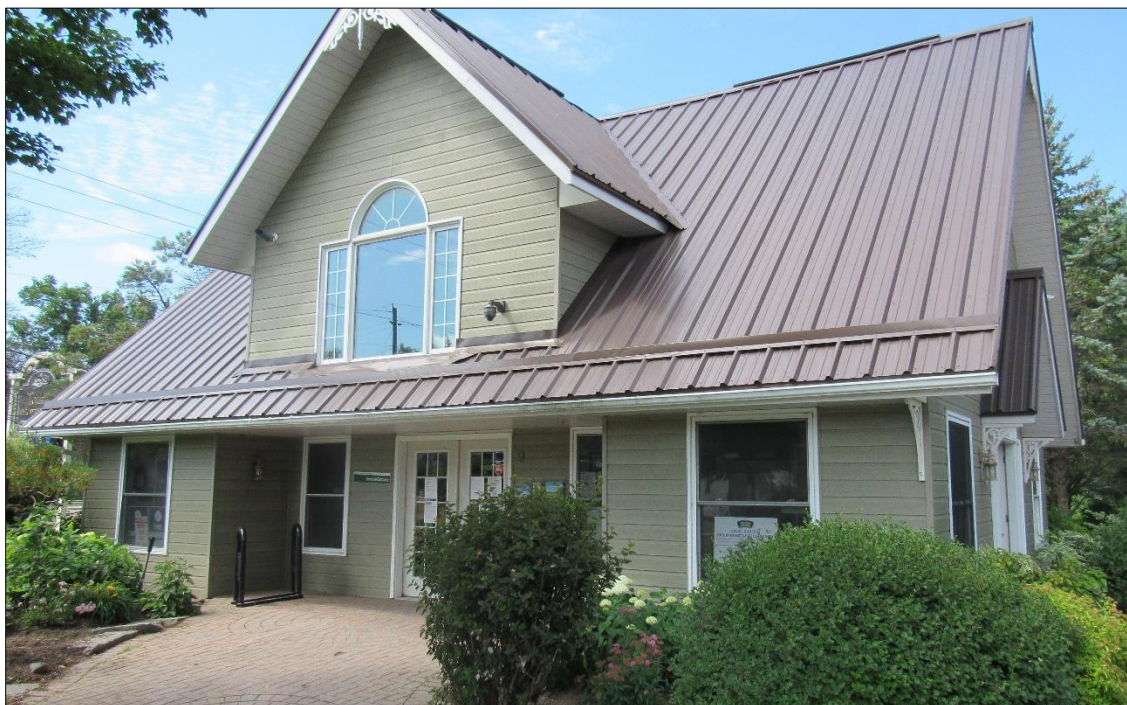
**Figure 36 - Tourist Information Centre**

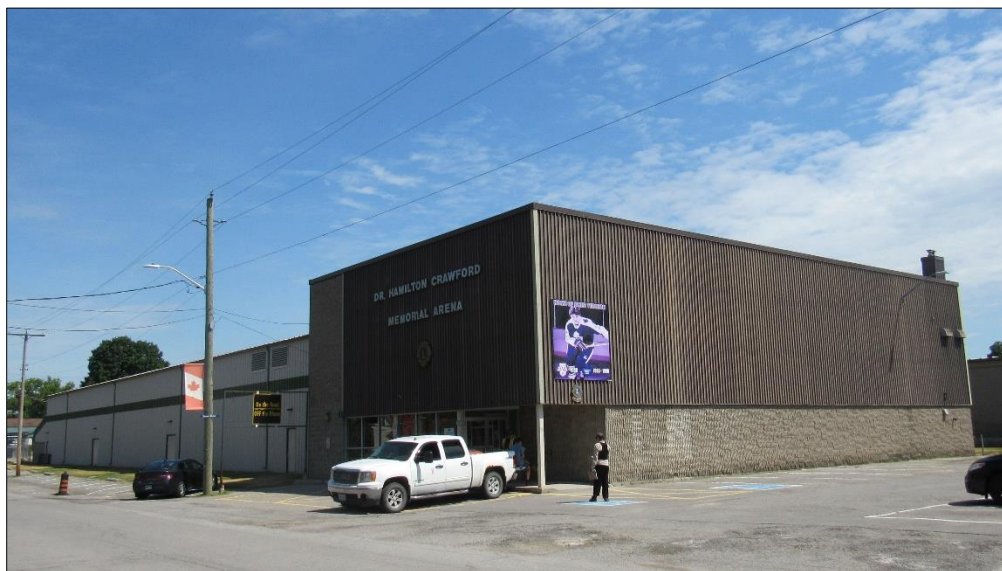
**Figure 37 - Marmora & District Community Centre**

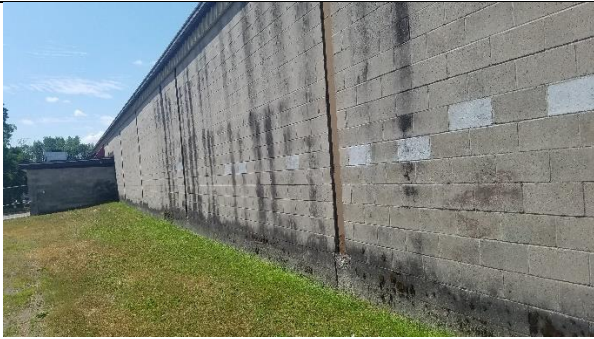
**Figure 38 - Concrete elements deteriorated**

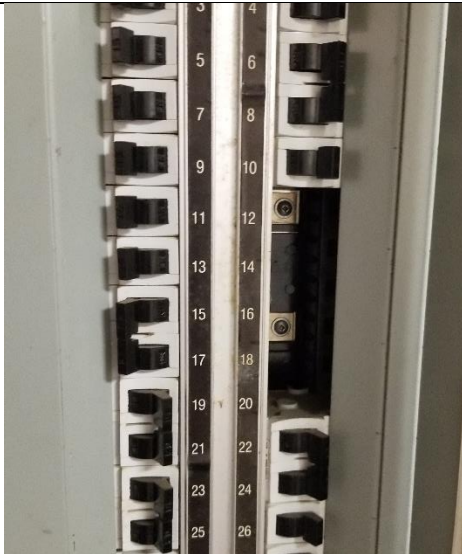
**Figure 39 - Open electrical panel slots**

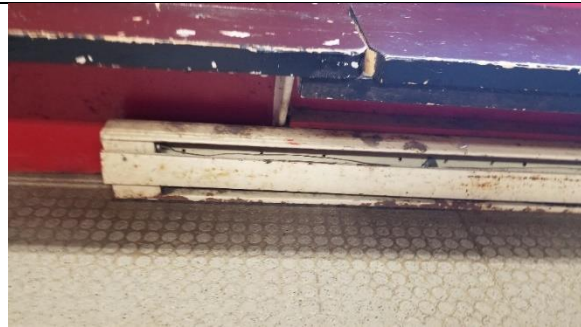
**Figure 40 - Corroded baseboard heater**

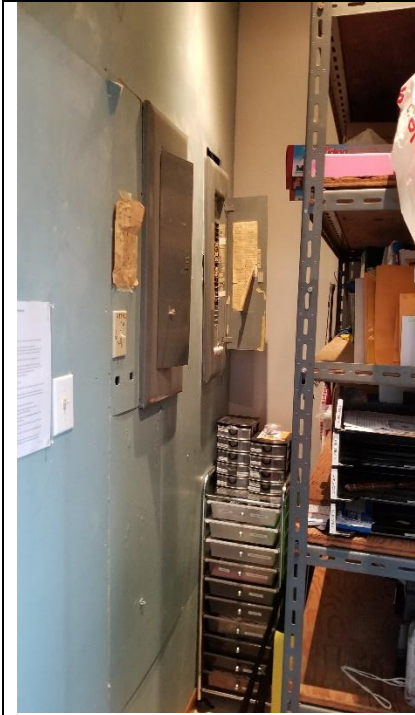
**Figure 41 - Blocked electrical panel access**

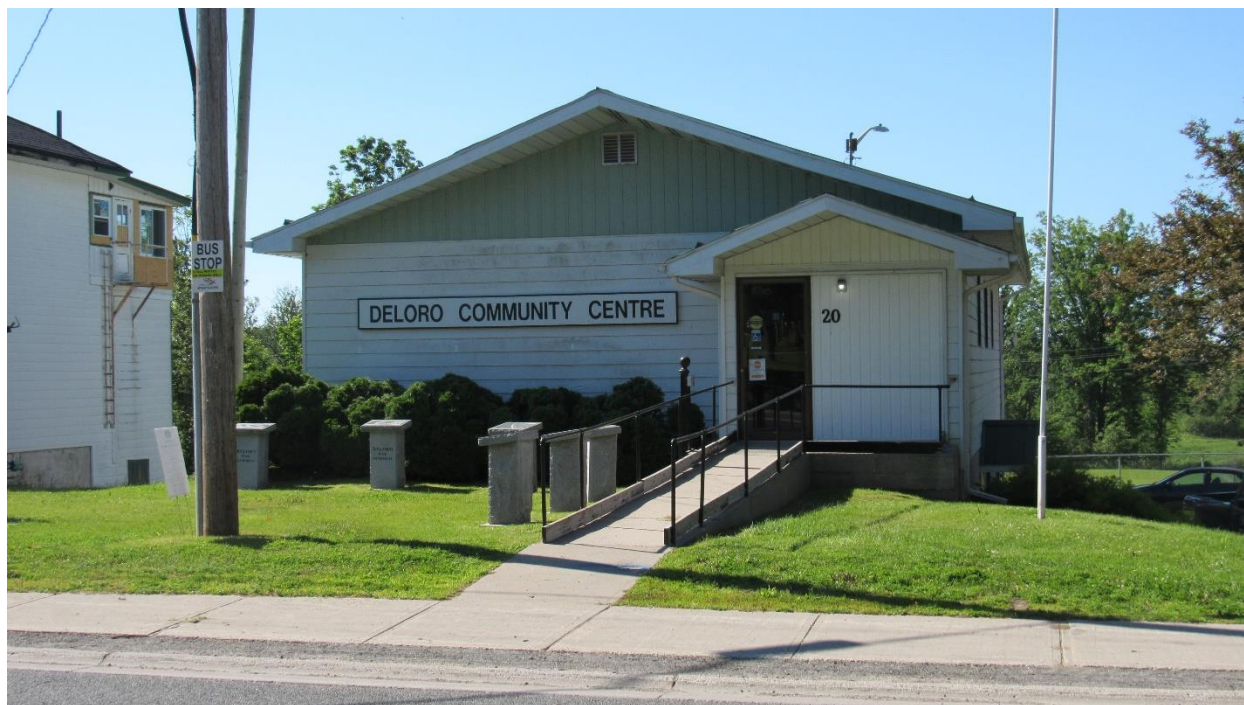
### **Site Information**

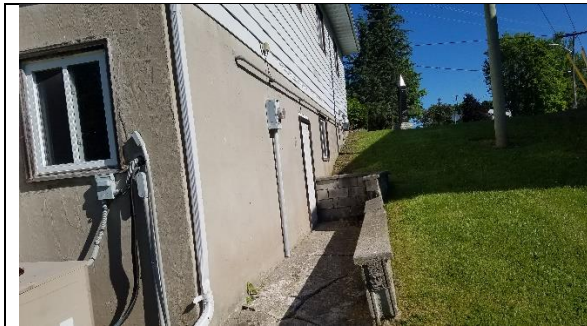
Figure 42 - Emergency exit of east face
